SUMMARY OF FLIGHTS AND TYPES OF DATA  
COLLECTED ABOARD THE UNIVERSITY  
OF WASHINGTON'S CONVAIR-580 RESEARCH  
AIRCRAFT IN IMPROVE-II: OROGRAPHIC STUDIES  
(26 NOVEMBER–22 DECEMBER 2001)

Compiled  
by  
Peter V. Hobbs

July 2002

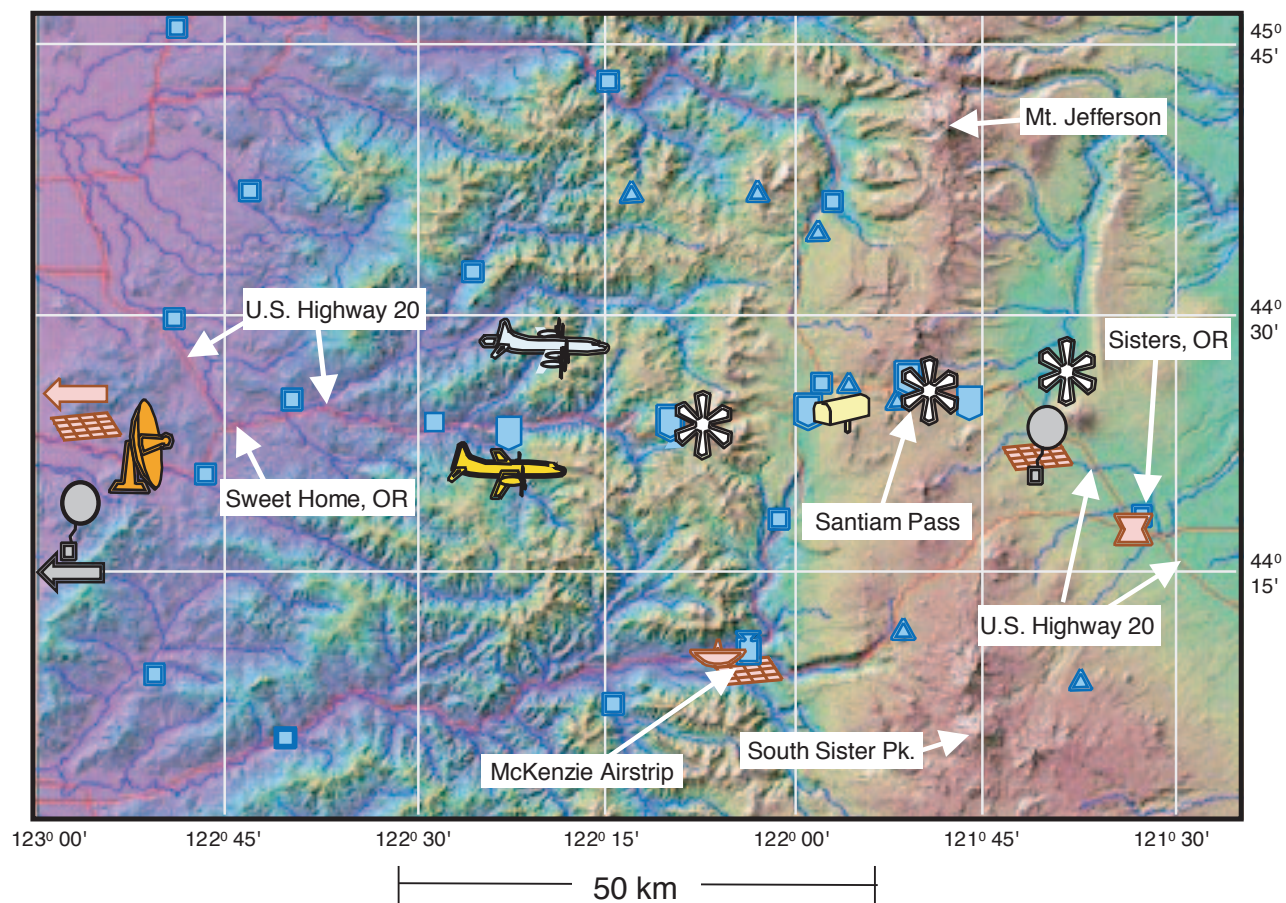
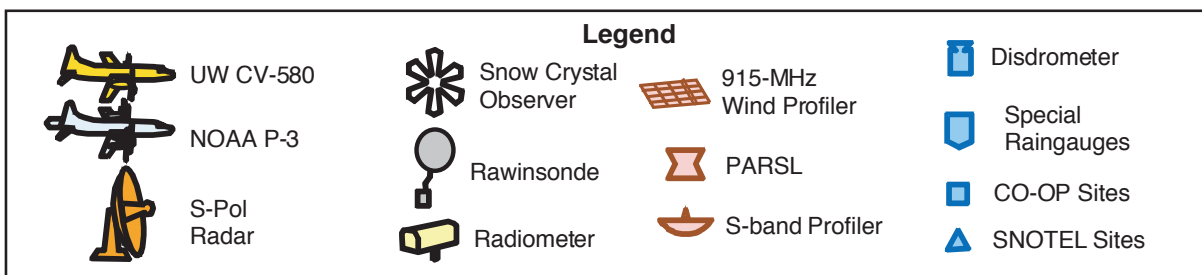
**Figure 1.1.** Observing facilities for IMPROVE-II.

The facilities deployed in this region are depicted in Figure 1.1. As in IMPROVE-I, cloud and precipitation microphysical measurements were provided primarily by the UW Convair-580 research aircraft. Air motions, required to place the microphysical measurements in context, were provided by the fore-aft-scanning X-band Doppler radar on a NOAA WP-3D Orion (P-3) aircraft. The P-3 generally flew a prescribed flight path above the Convair-580 as the latter aircraft obtained in situ measurements across the Cascades.

Other field facilities included the NCAR S-Pol Doppler radar, a 915 MHz wind profiler, dedicated rawinsonde launches, special precipitation gauges, personnel on the mountain to observe snow crystal types, the Pacific Northwest National Laboratory PARSL remote sensing unit, and disdrometer measurements for raindrop size distributions on the ground (see Figure 1.1).

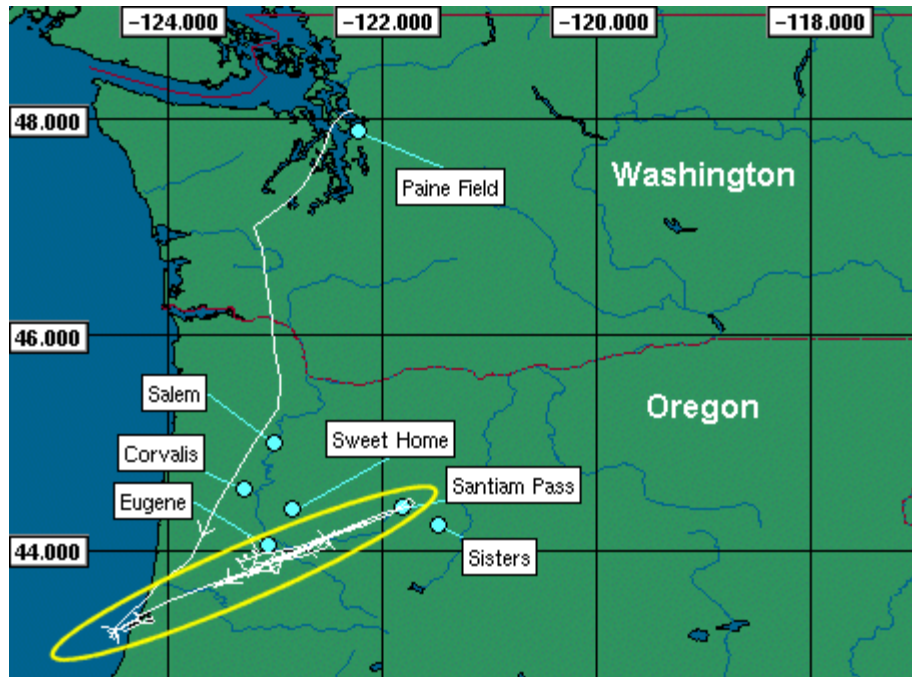
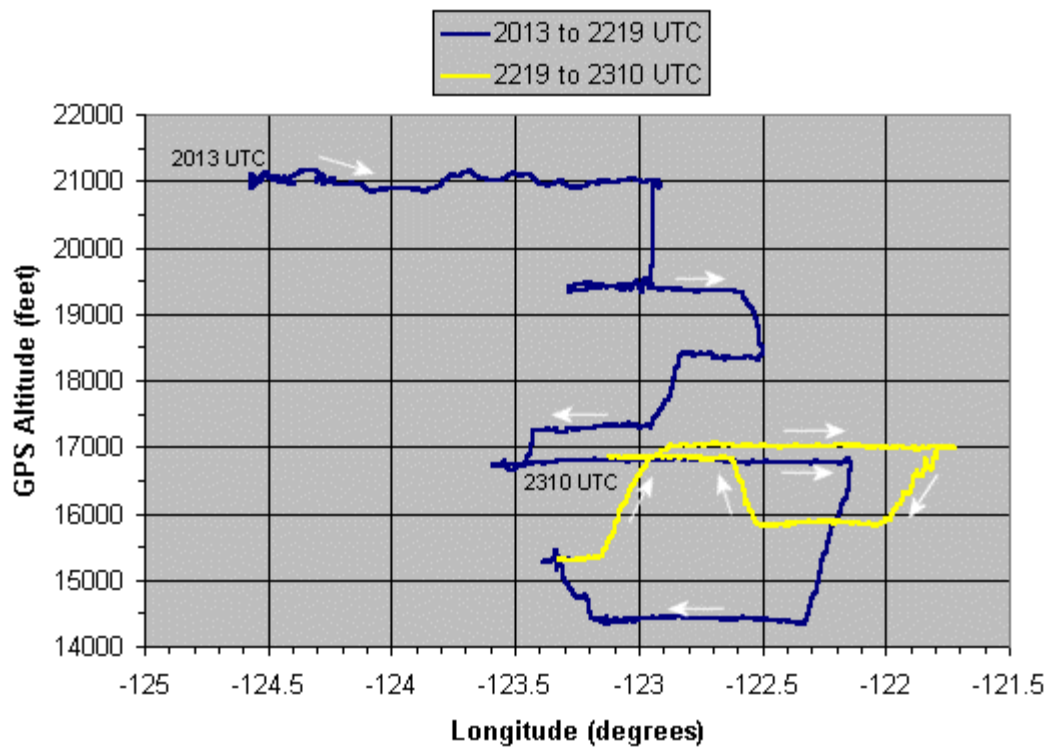
**Figure 4.1.** Flight track (white line) of the Convair-580 in IMPROVE-II on November 28, 2001 (UW Flight 1891).

### Flight 1891 – Aircraft Path – 1825 to 2320 UTC

### Flight 1891 – Vertical Profile – 2013 to 2310 UTC

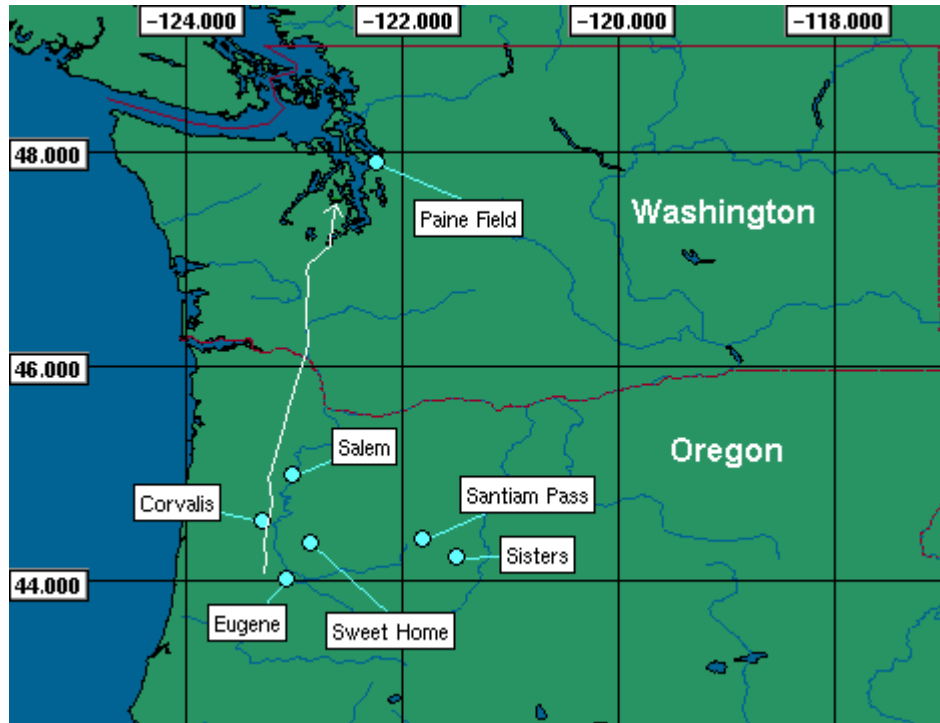
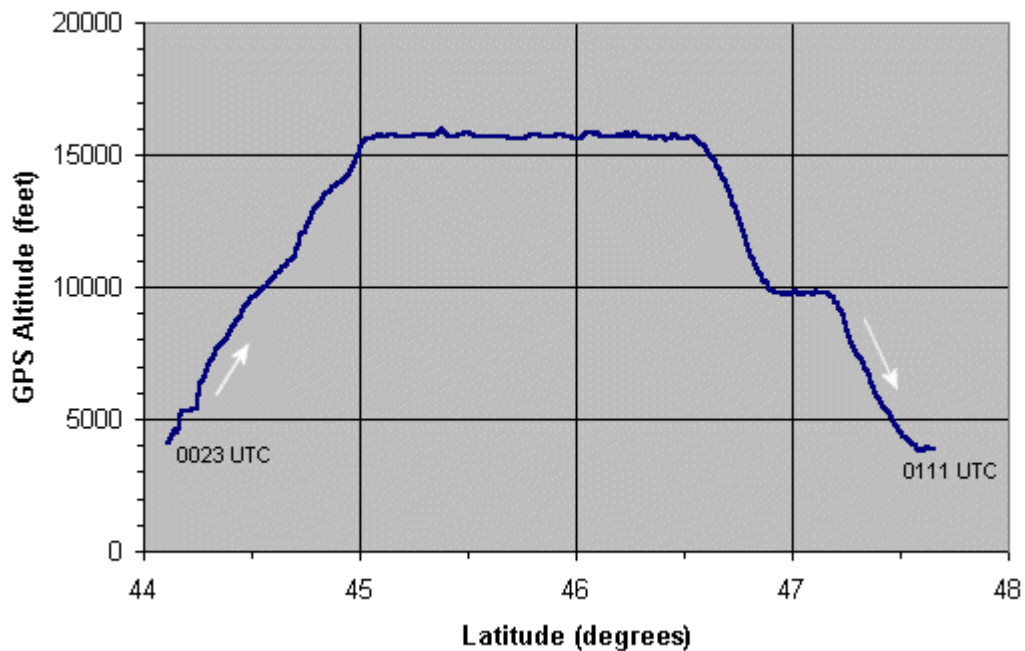
**Figure 4.2.** Flight track (white line) of the Convair-580 in IMPROVE-II on November 29, 2001 (UW Flight 1892).

### Flight 1892 – Aircraft Path – 0023 to 0111 UTC

### Flight 1892 – Vertical Profile – 0023 to 0111 UTC

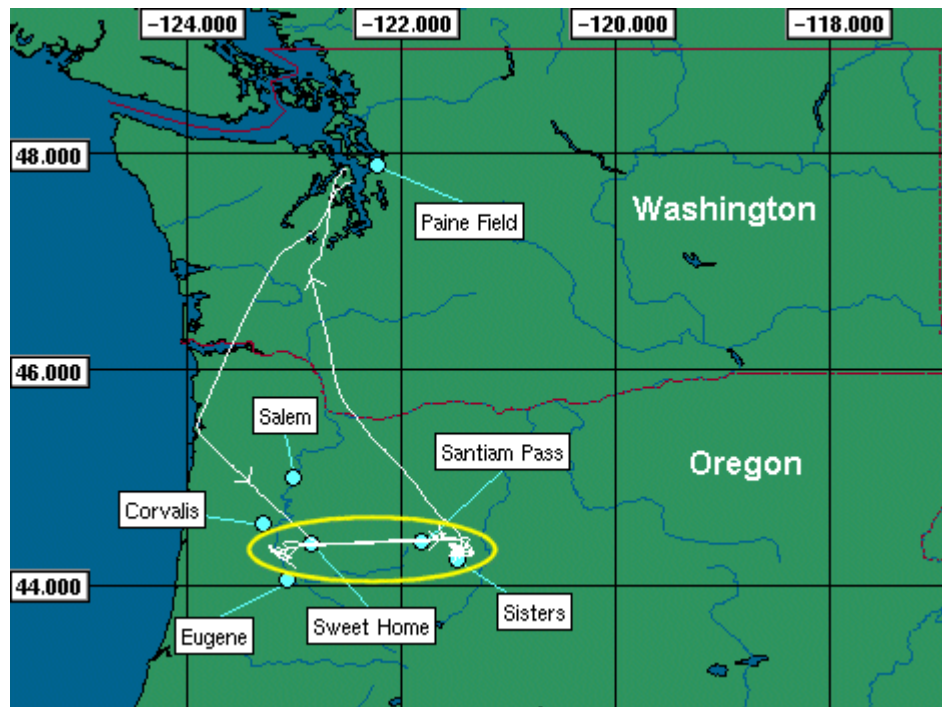
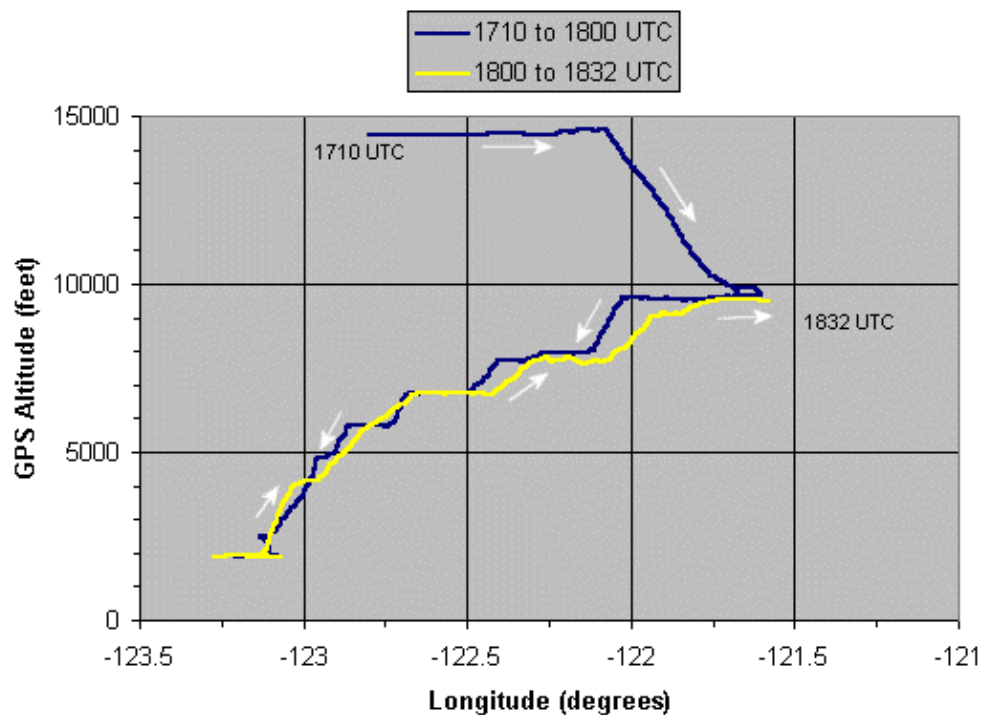
**Figure 4.3.** Flight track (white line) of the Convair-580 in IMPROVE-II on November 29, 2001 (UW Flight 1893).

### Flight 1893 – Aircraft Path – 1612 to 2034 UTC

### Flight 1893 – Vertical Profile – 1710 to 1832 UTC

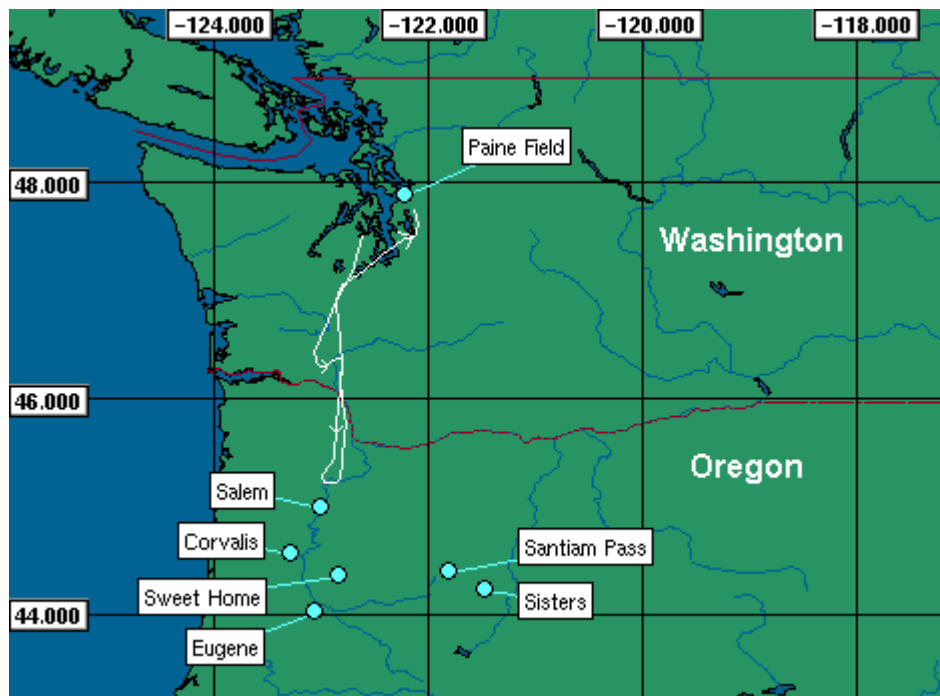
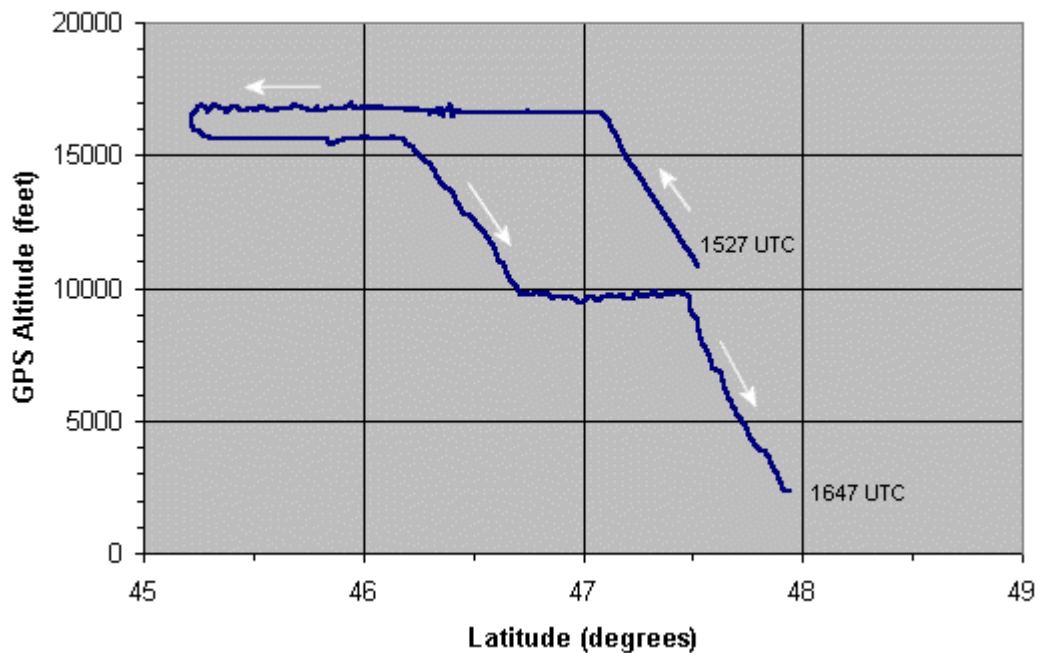
**Figure 4.4.** Flight track (white line) of the Convair-580 in IMPROVE-II on December 1, 2001 (UW Flight 1894).

### Flight 1894 – Aircraft Path – 1527 to 1647 UTC

### Flight 1894 – Vertical Profile – 1527 to 1647 UTC

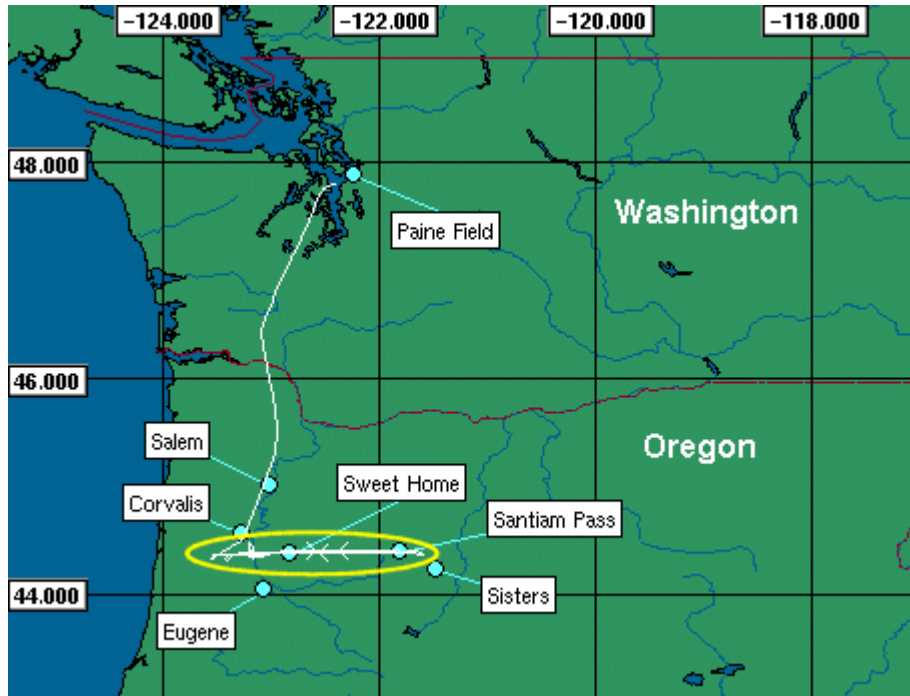
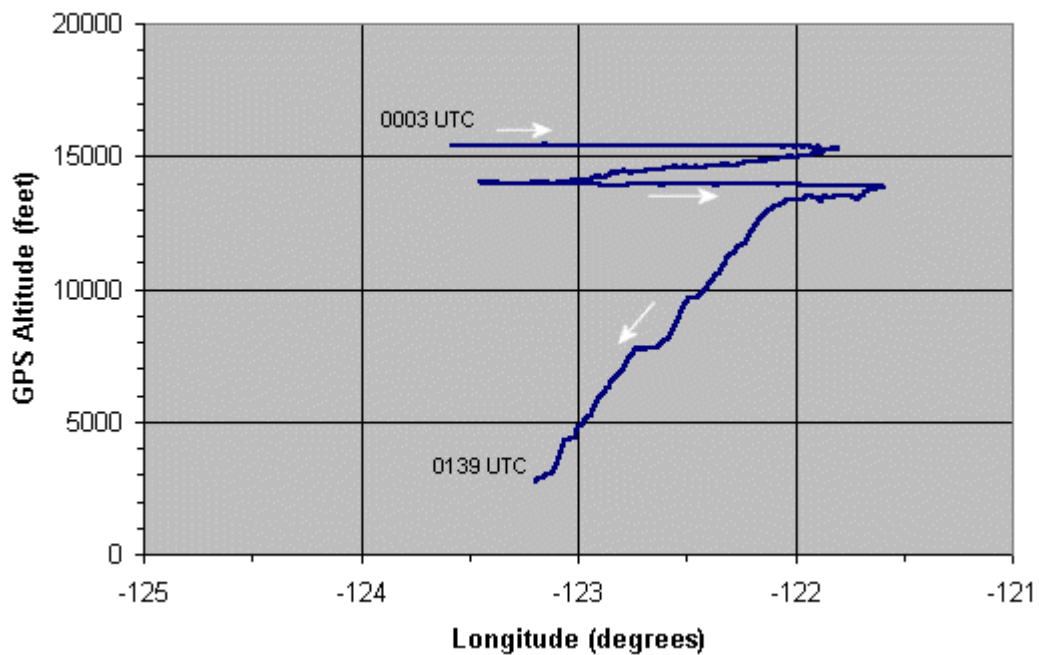
**Figure 4.5.** Flight track (white line) of the Convair-580 in IMPROVE-II on December 4-5, 2001 (UW Flight 1895).

### Flight 1895 – Aircraft Path – 2300 to 0141 UTC

### Flight 1895 – Vertical Profile – 0003 to 0139 UTC

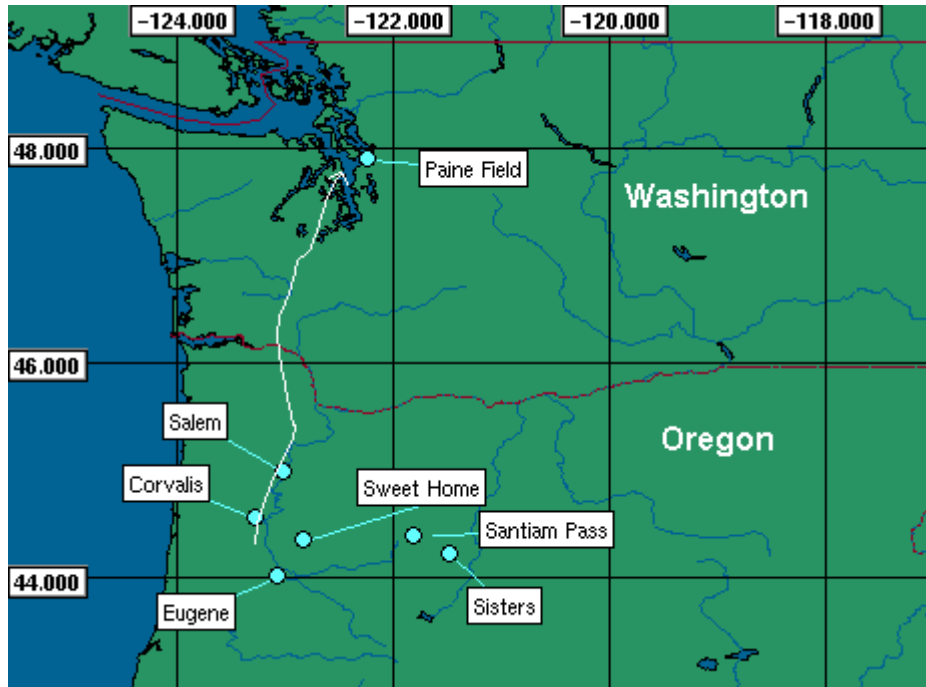
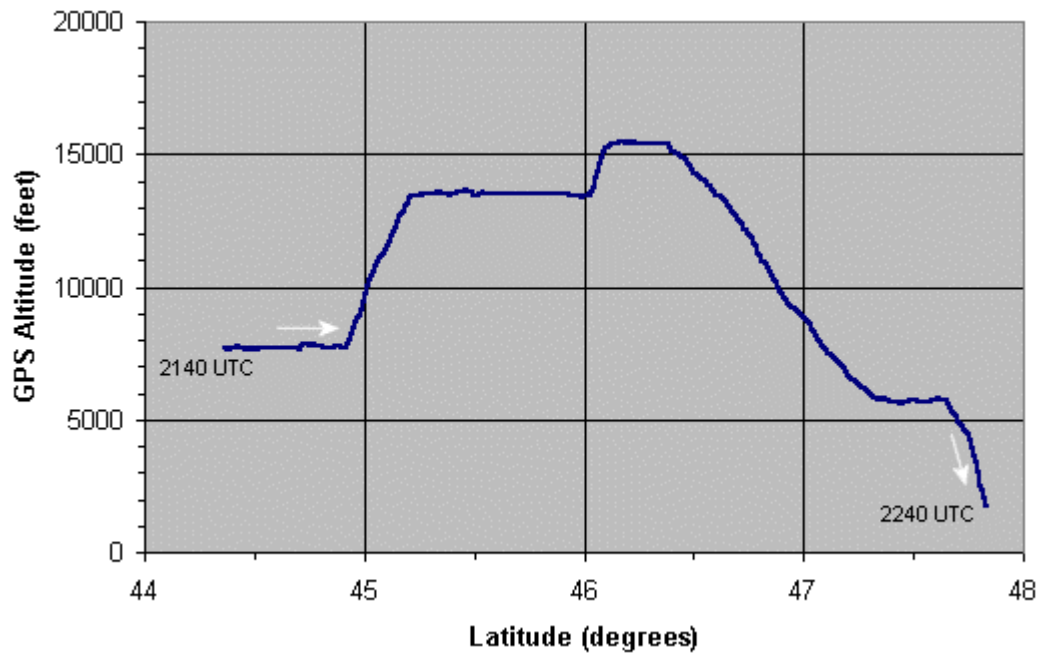
**Figure 4.6.** Flight track (white line) of the Convair-580 in IMPROVE-II on December 5, 2001 (UW Flight 1896).

### Flight 1896 – Aircraft Path – 2140 to 2240 UTC

### Flight 1896 – Vertical Profile – 2140 to 2240 UTC

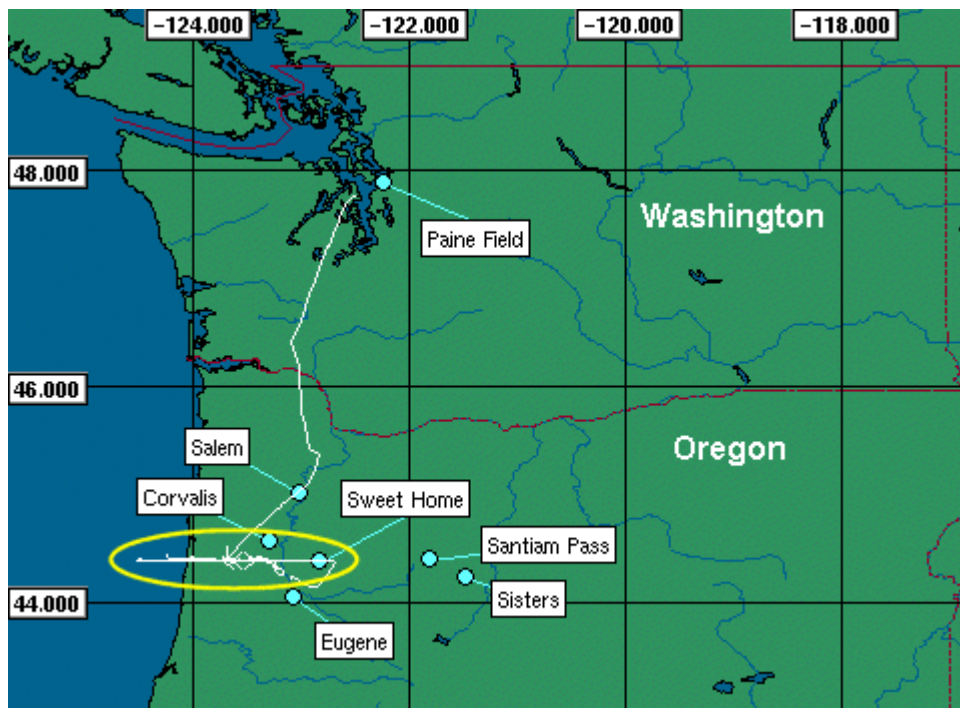
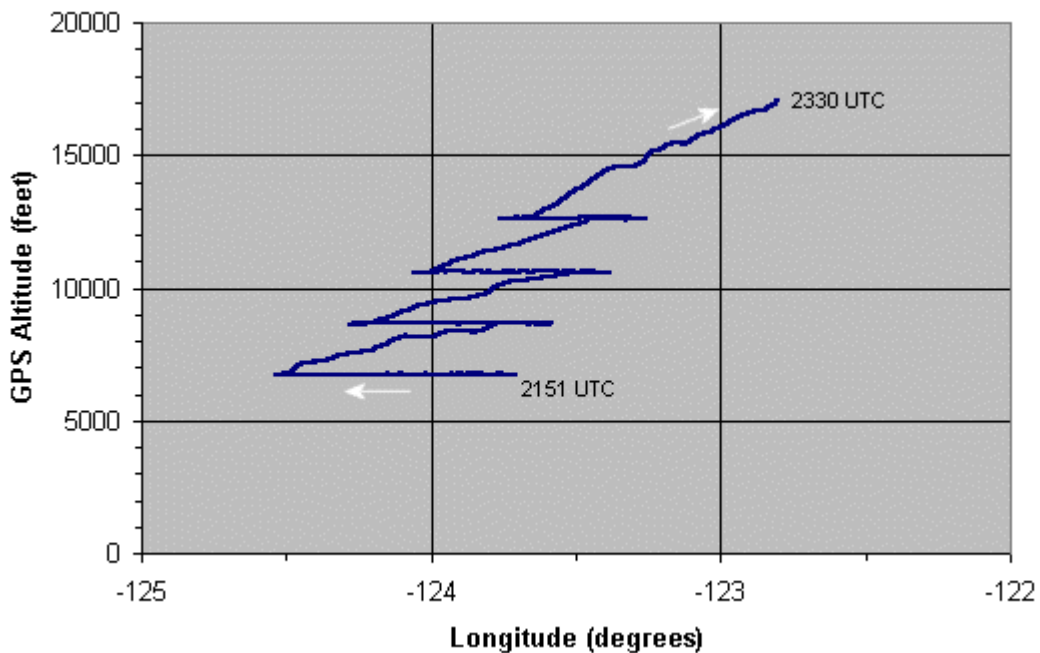
**Figure 4.7.** Flight track (white line) of the Convair-580 in IMPROVE-II on December 8, 2001 (UW Flight 1897).

### Flight 1897 – Aircraft Path – 2033 to 2344 UTC

### Flight 1897 – Vertical Profile – 2151 to 2330 UTC

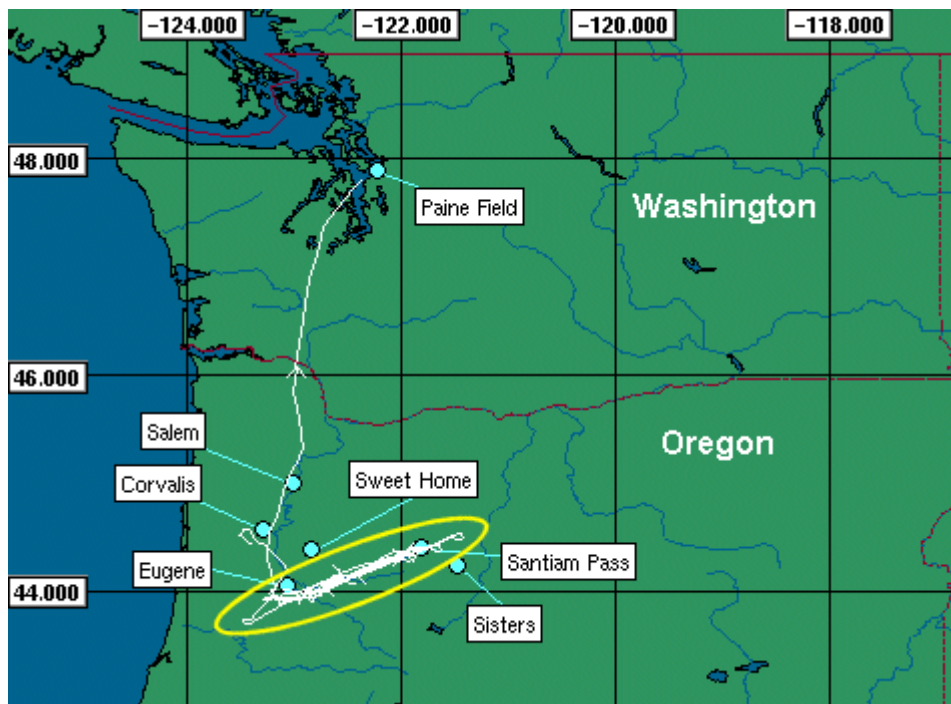
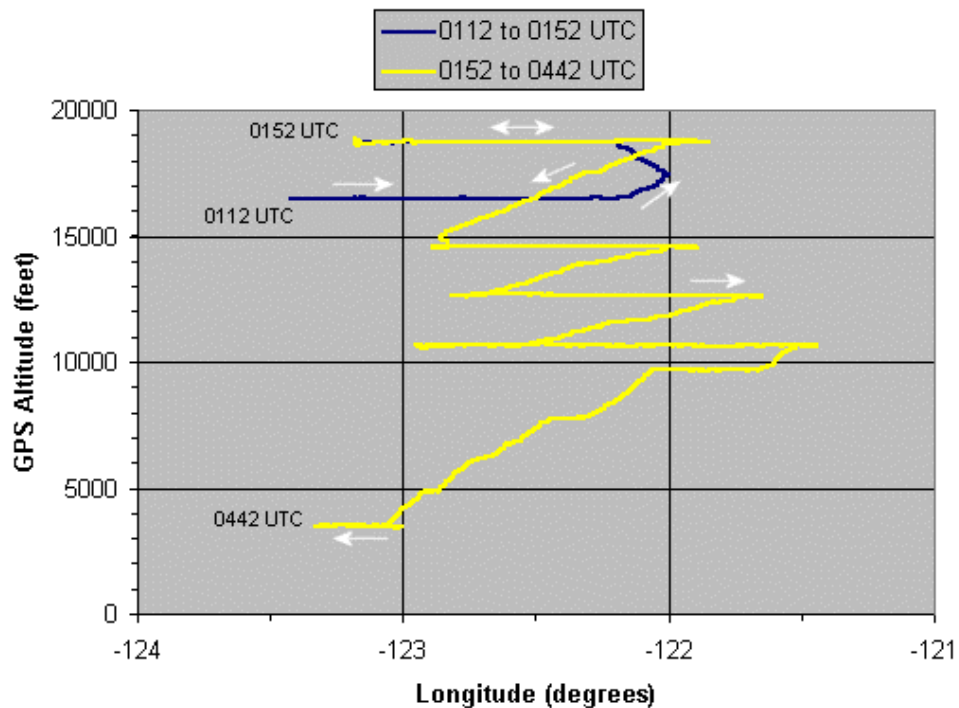
**Figure 4.8.** Flight track (white line) of the Convair-580 in IMPROVE-II on December 9, 2001 (UW Flight 1898).

### Flight 1898 – Aircraft Path – 0045 to 0555 UTC

### Flight 1898 – Vertical Profile – 0112 to 0442 UTC

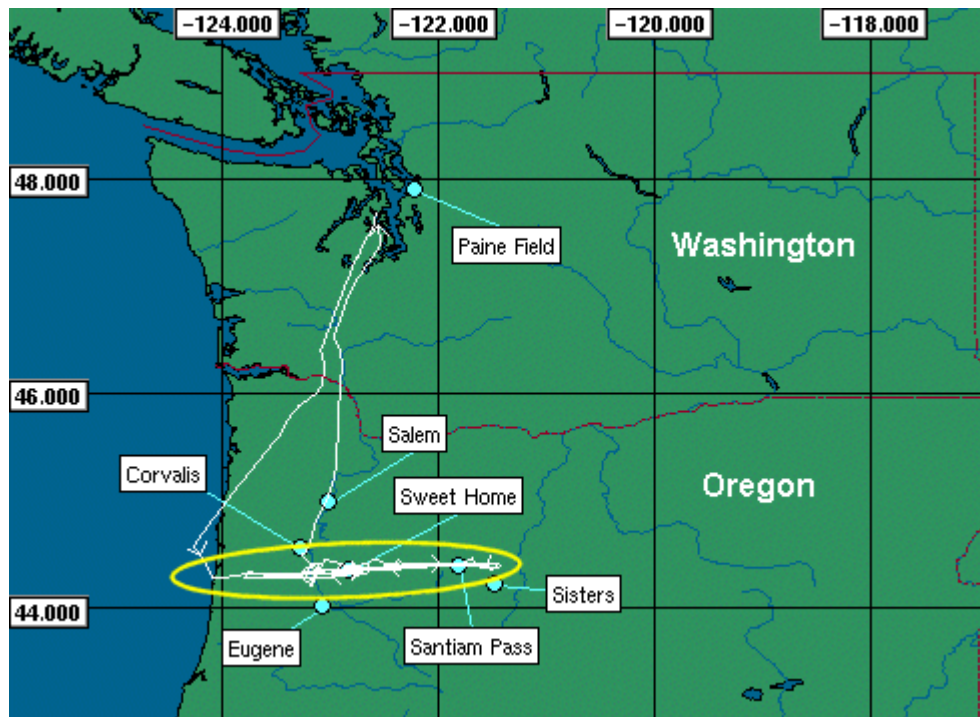
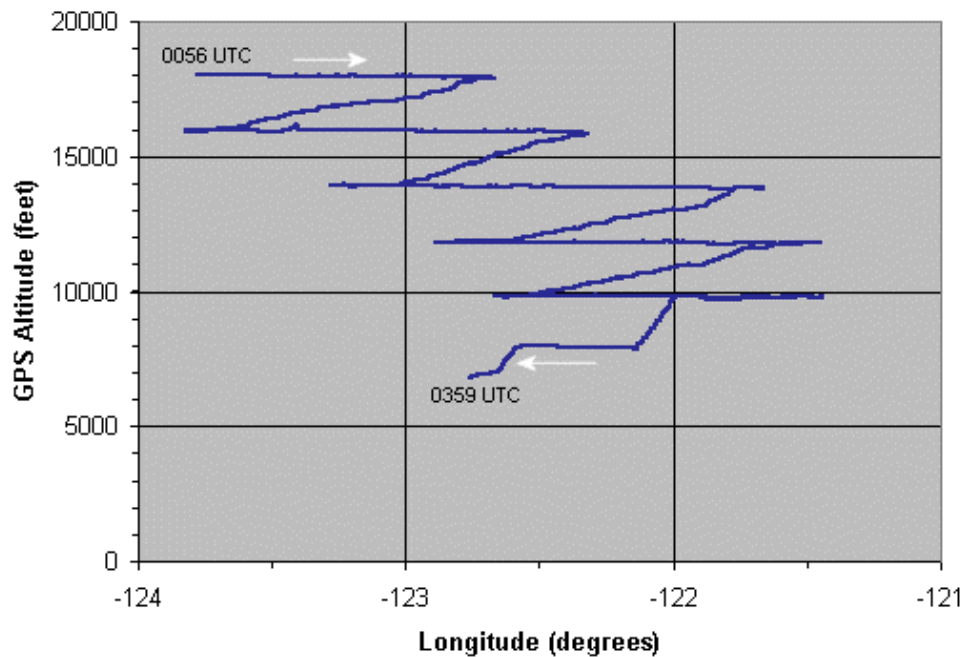
**Figure 4.9.** Flight track (white line) of the Convair-580 in IMPROVE-II on December 12-13, 2001 (UW Flight 1899).

### Flight 1899 – Aircraft Path – 2351 to 0527 UTC

### Flight 1899 – Vertical Profile – 0056 to 0359 UTC

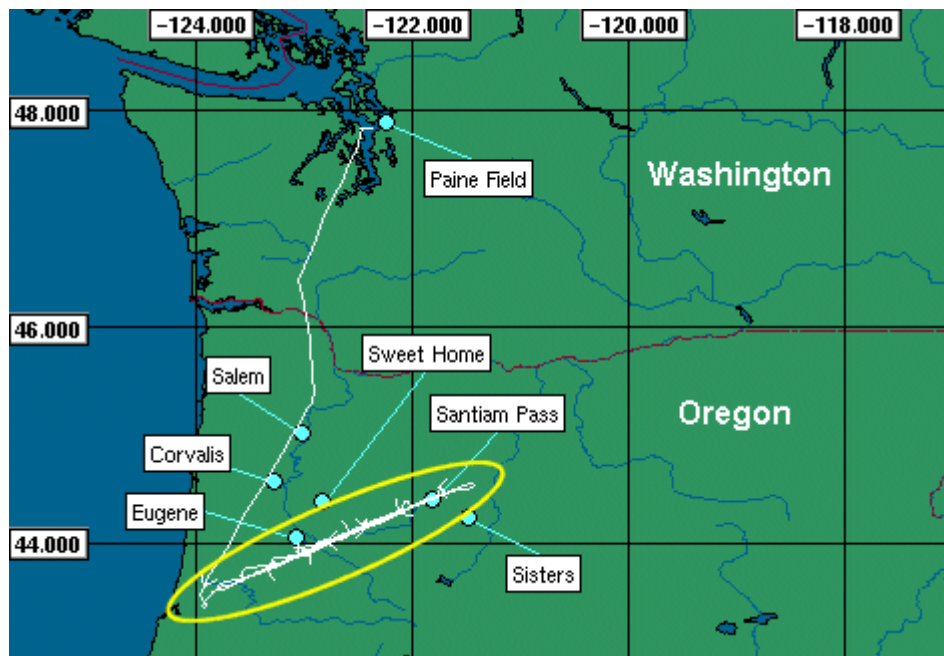
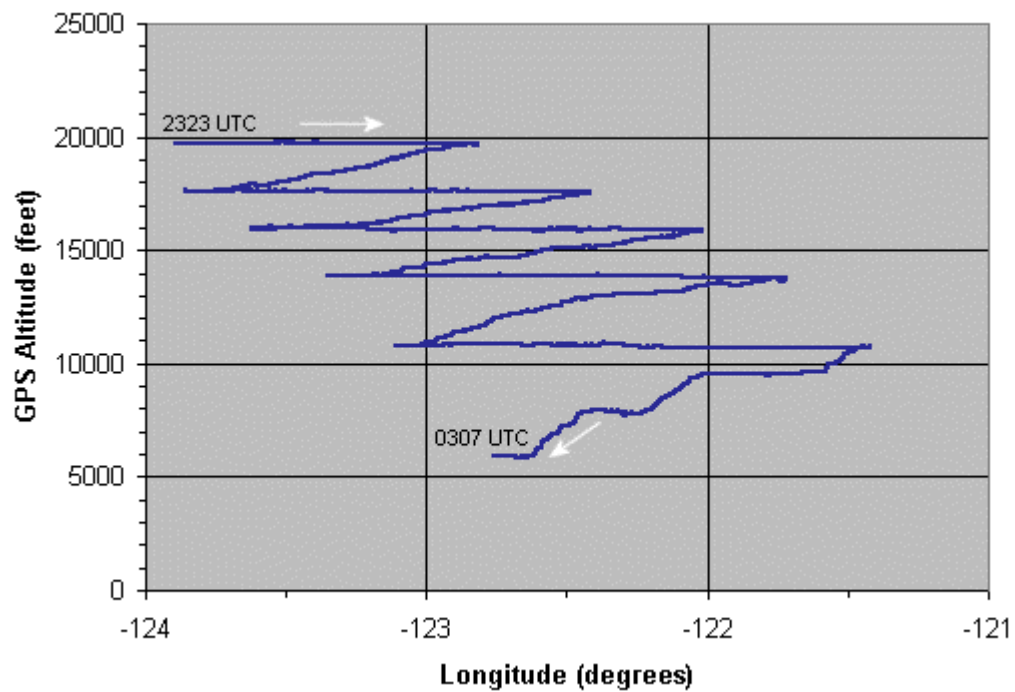
**Figure 4.10.** Flight track (white line) of the Convair-580 in IMPROVE-II on December 13-14, 2001 (UW Flight 1900).

### Flight 1900 – Aircraft Path – 2147 to 0309 UTC

### Flight 1900 – Vertical Profile – 2323 to 0307 UTC

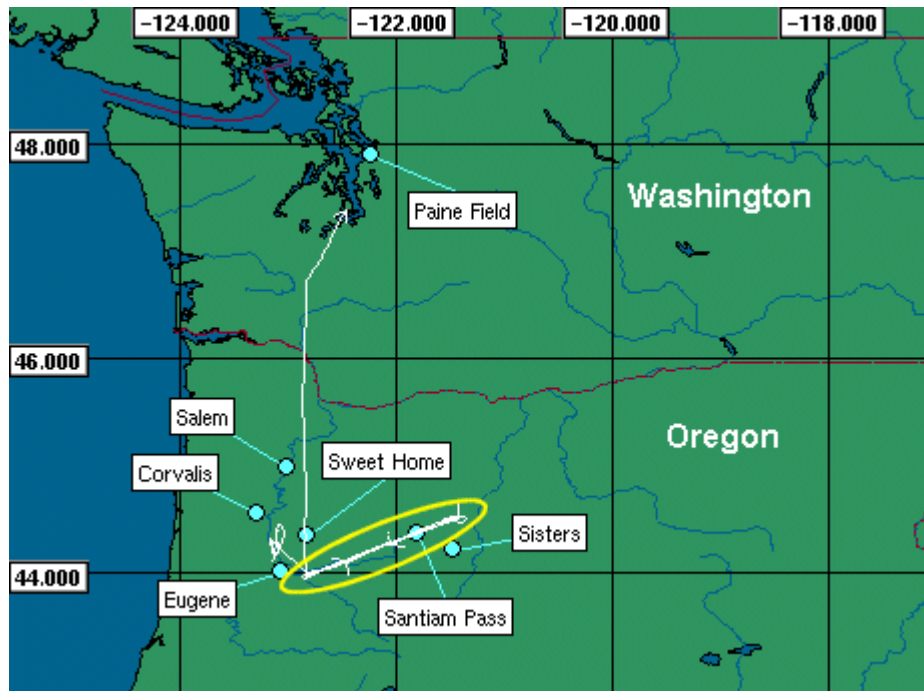
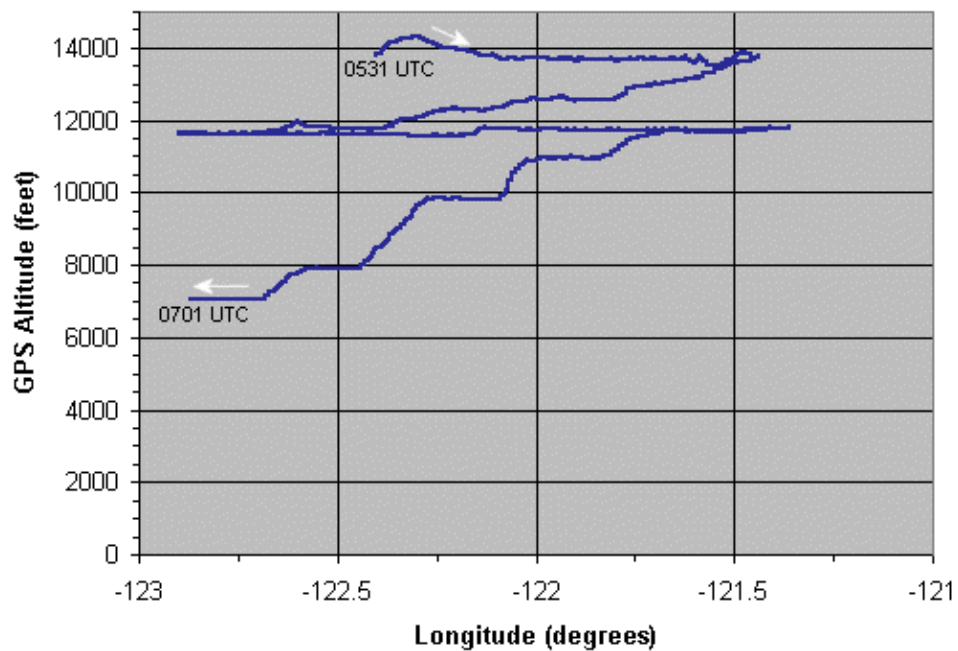
**Figure 4.11.** Flight track (white line) of the Convair-580 in IMPROVE-II on December 14, 2001 (UW Flight 1901).

### Flight 1901 – Aircraft Path – 0454 to 0757 UTC

### Flight 1901 – Vertical Profile – 0531 to 0701 UTC

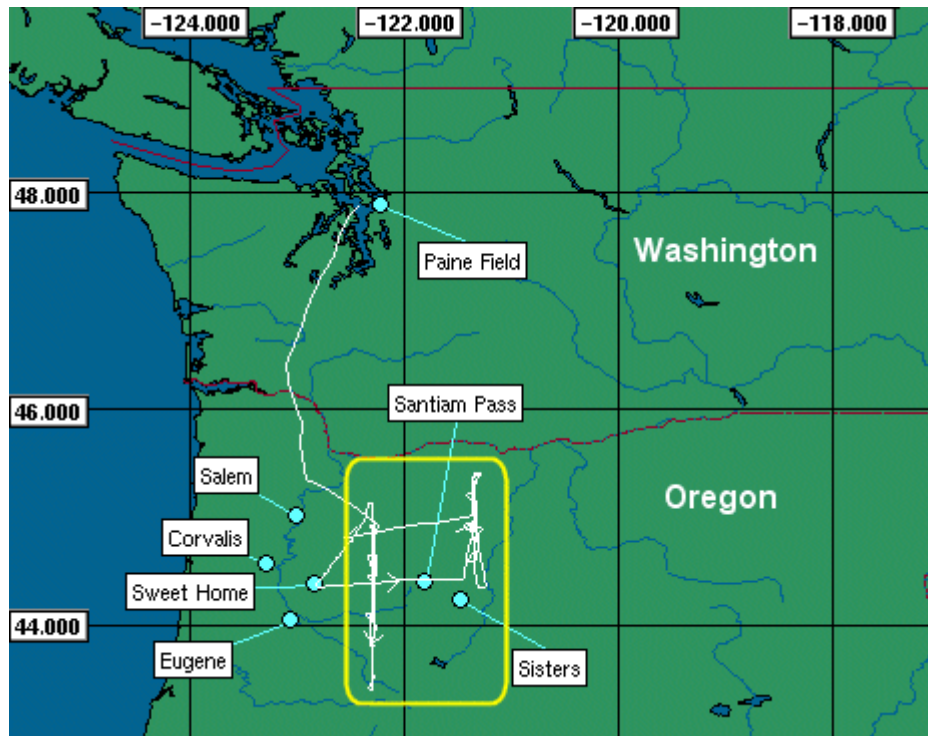
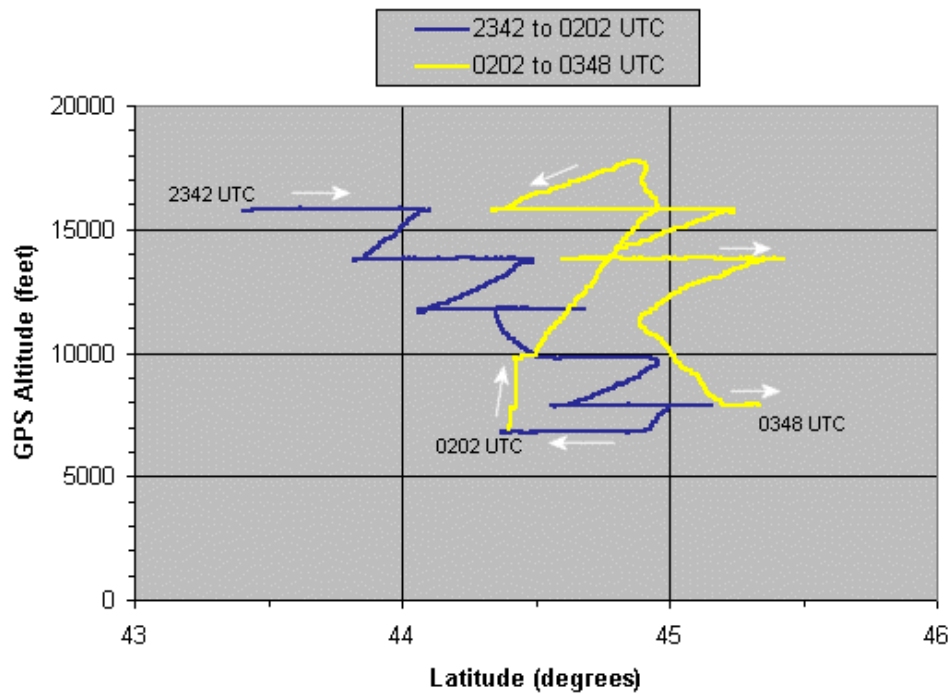
**Figure 4.12.** Flight track (white line) of the Convair-580 in IMPROVE-II on December 19-20, 2001 (UW Flight 1902).

### Flight 1902 – Aircraft Path – 2246 to 0405 UTC

### Flight 1902 – Vertical Profile – 2342 to 0348 UTC

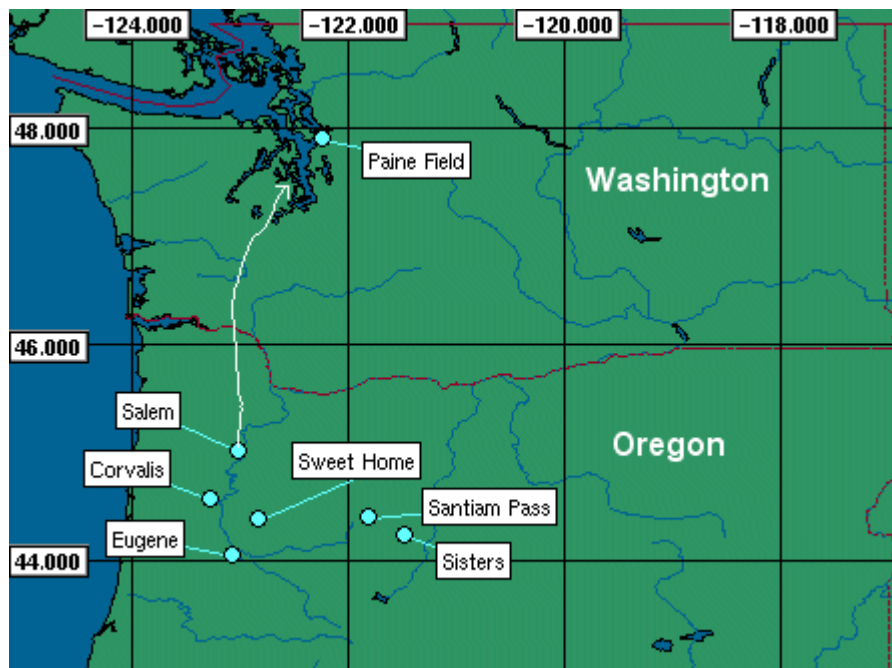
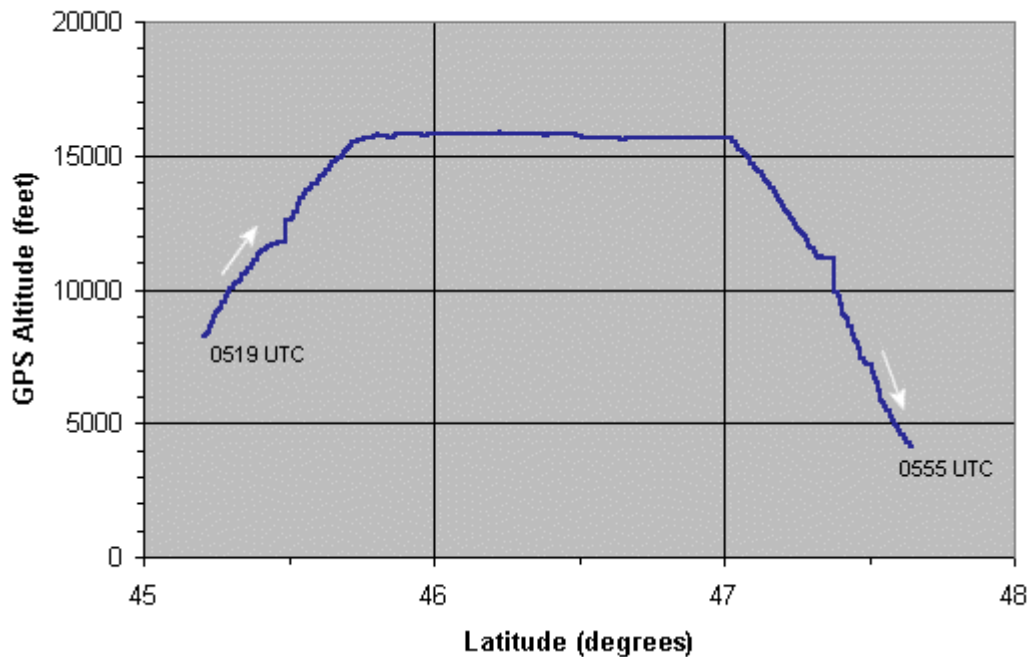
**Figure 4.13.** Flight track (white line) of the Convair-580 in IMPROVE-II on December 20, 2001 (UW Flight 1903).

### Flight 1903 – Aircraft Path – 0519 to 0555 UTC

### Flight 1903 – Vertical Profile – 0519 to 0555 UTC

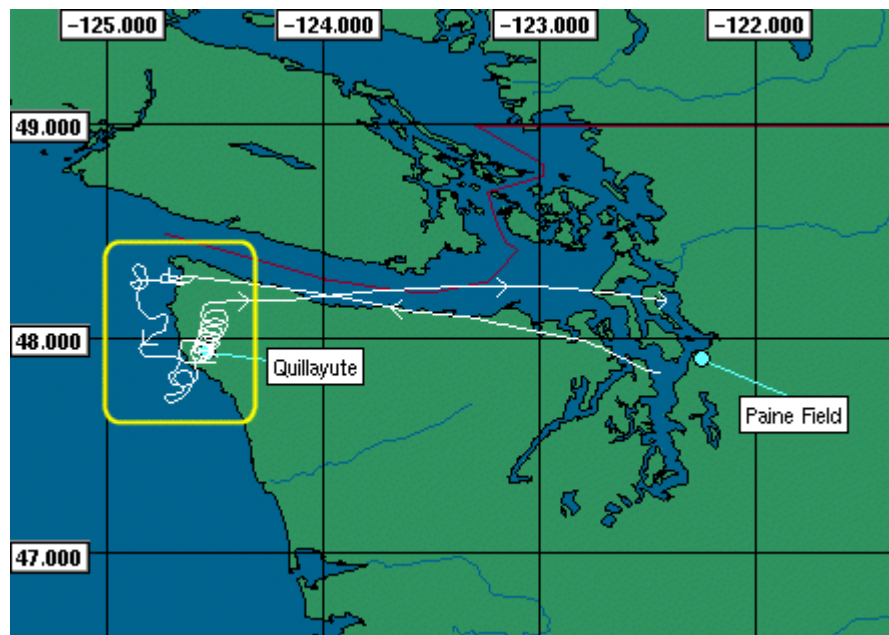
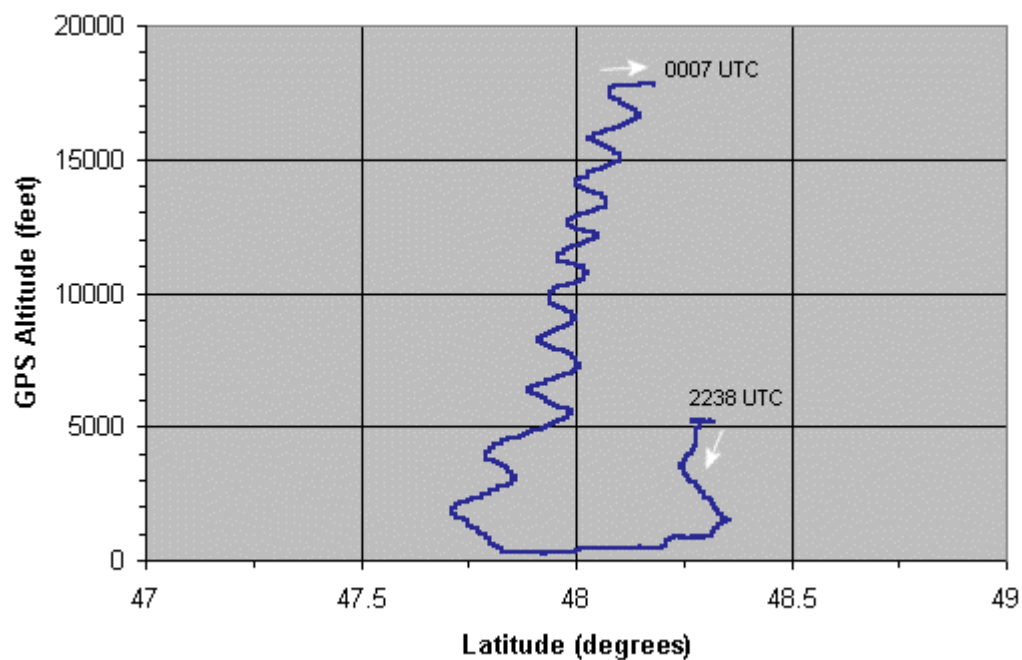
**Figure 4.14.** Flight track (white line) of the Convair-580 in IMPROVE-II on December 21-22, 2001 (UW Flight 1904).

### Flight 1904 – Aircraft Path – 2213 to 0032 UTC

### Flight 1904 – Vertical Profile – 2238 to 0007 UTC

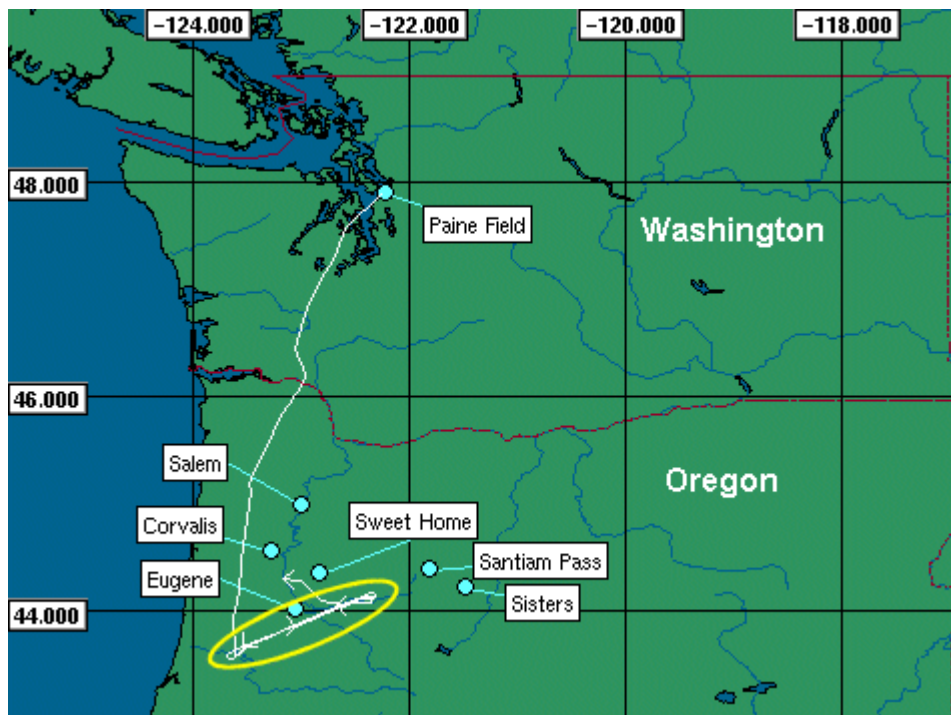
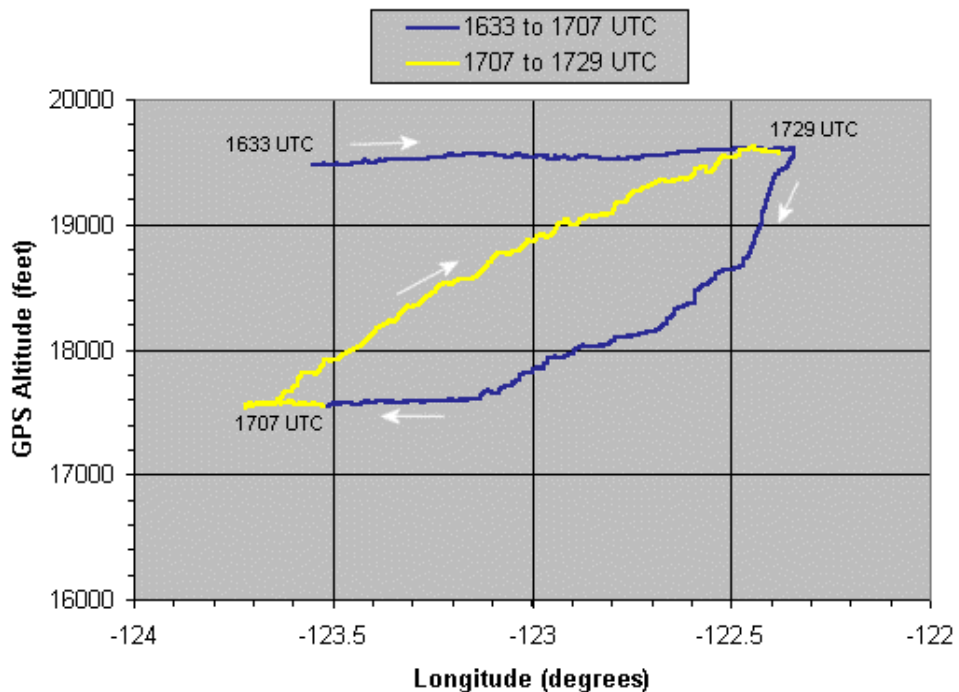
**Figure 4.15.** Flight track (white line) of the Convair-580 in IMPROVE-II on December 22, 2001 (UW Flight 1905).

### Flight 1905 – Aircraft Path – 1517 to 1748 UTC

### Flight 1905 – Vertical Profile – 1633 to 1729 UTC
