SUMMARY OF FLIGHTS AND TYPES OF DATA  
COLLECTED ABOARD THE UNIVERSITY  
OF WASHINGTON'S CONVAIR-580 RESEARCH  
AIRCRAFT IN IMPROVE-II: OROGRAPHIC STUDIES  
(26 NOVEMBER–22 DECEMBER 2001)

Compiled  
by  
Peter V. Hobbs

July 2002

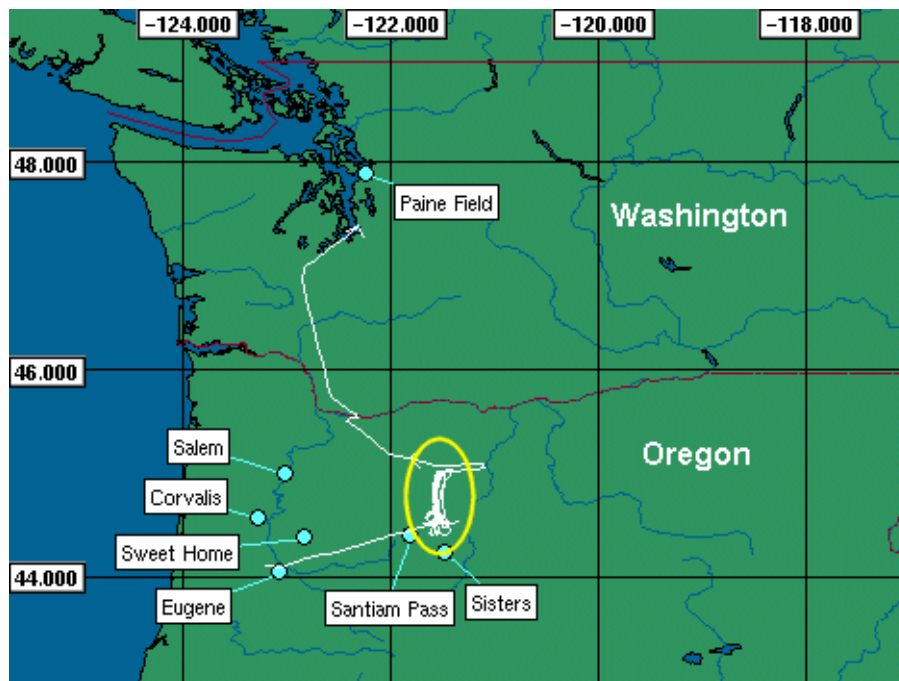
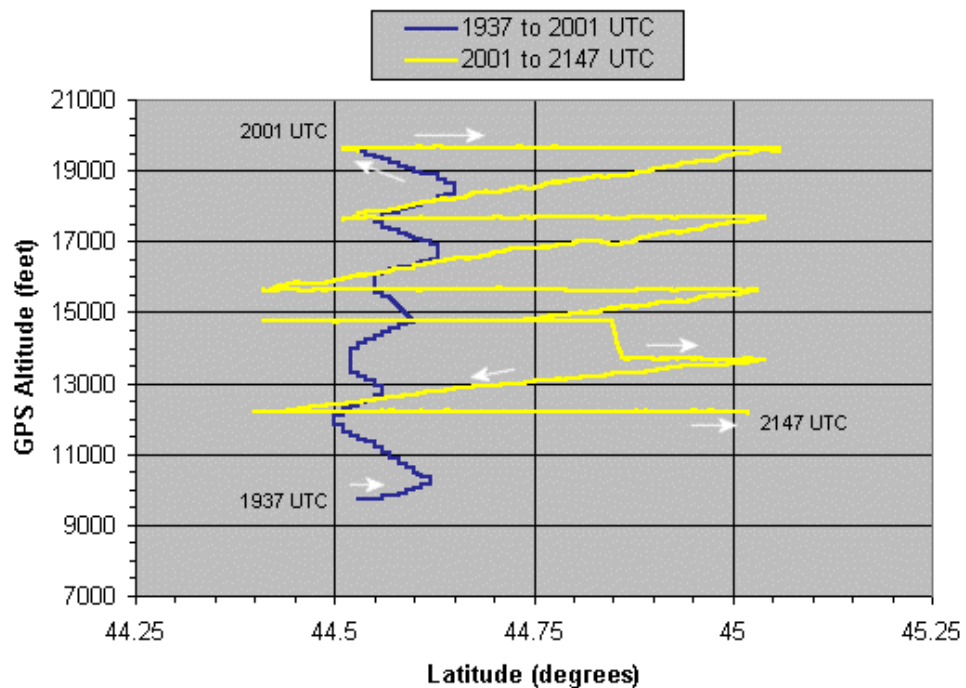
**Figure 4.16.** Flight track (white line) of the Convair-580 in IMPROVE-II on December 22, 2001 (UW Flight 1906).

### Flight 1906 – Aircraft Path – 1921 to 2249 UTC

### Flight 1906 – Vertical Profile – 1937 to 2147 UTC
